# 2025 - New Presbytery Windows and Essential Roof Repairs

## Phase 1: Presbytery Roof Repairs

## Phase 2: Presbytery Windows

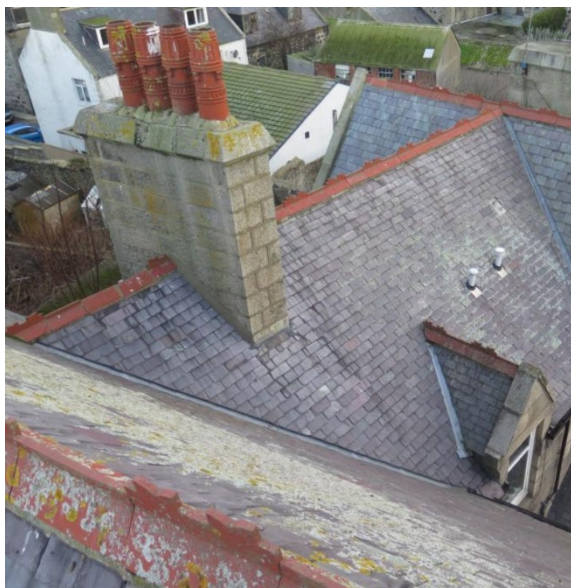
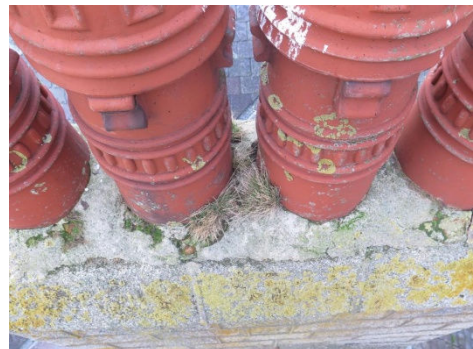
Before:

Poor apical tile mortaring and cracked mortar at the chimney haunches, letting in water.

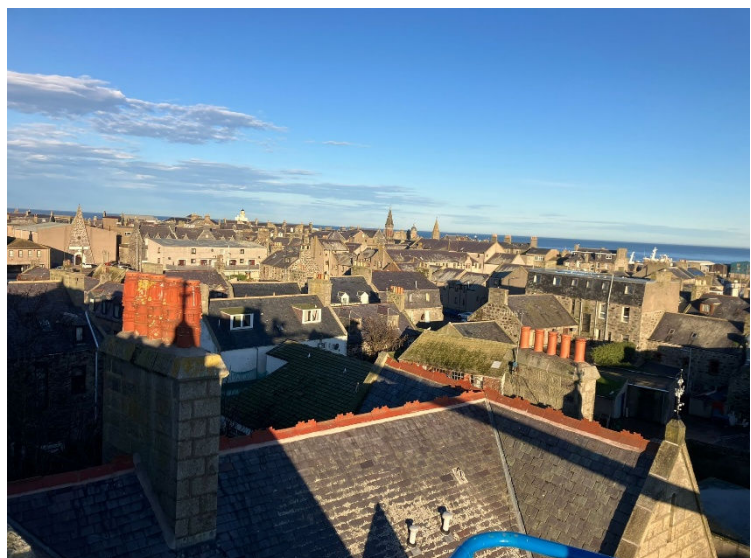
After:

Well-mortared chimneys and apical tiles.

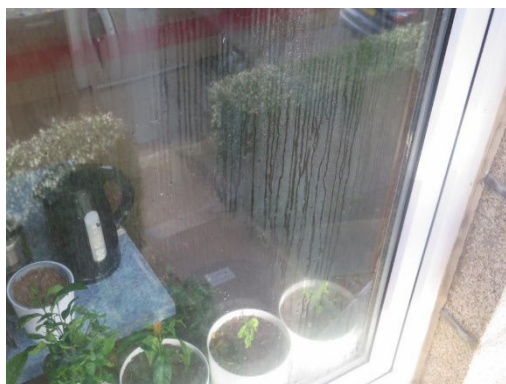
Before:

Damaged sealant, decaying frames, condensation in the double-glazing cavity...

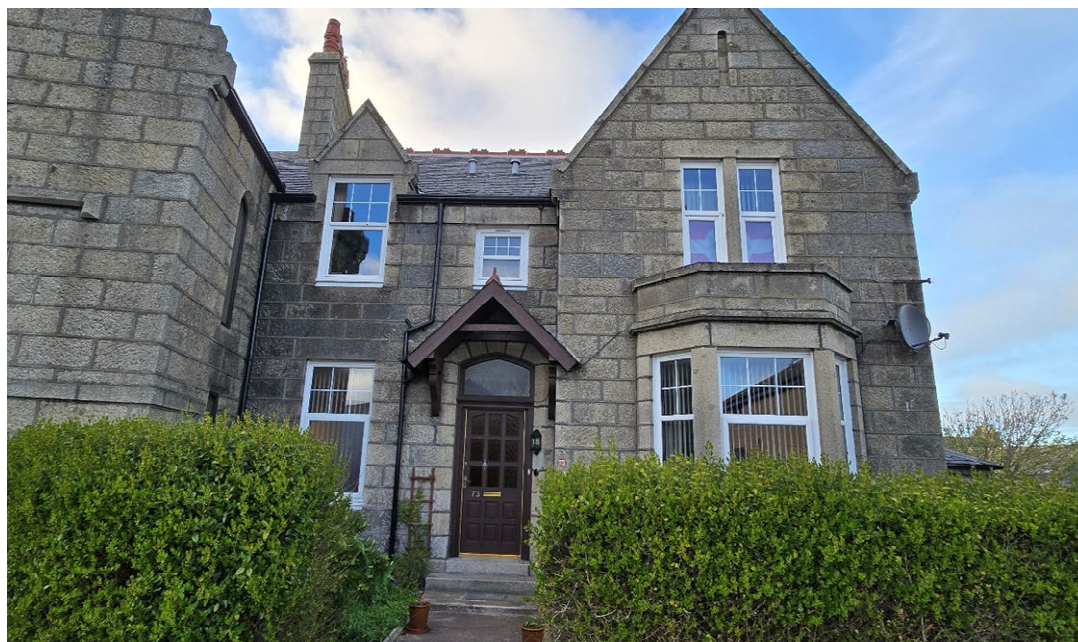
After:

Water-tight windows, and a better energy efficiency for this house which serves as a facility for parish socials, meetings and administration, as well as a residence for the ministers.
